Using Data Manager® 2000 to compete in the wholesale power market

by Ken Davis

and Jim Cable

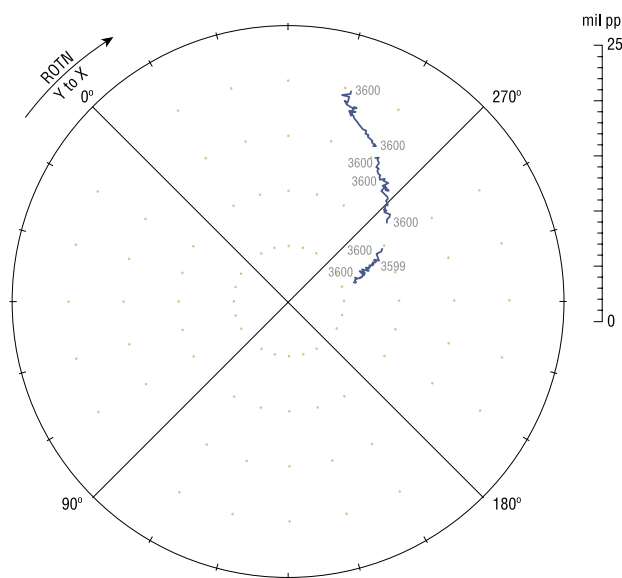
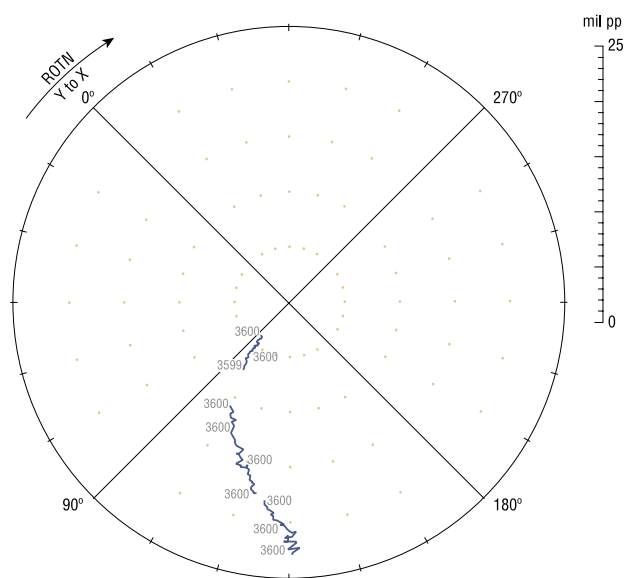
Figure 2. Steady state vibration response at bearings 3 and 4 due to thermally-induced rub.

The unit was returned to service and operated successfully until May 12, when System Dispatch asked that the unit load be reduced to minimum. Similar to the events of the previous trip, the vibration levels first increased on the T-3 and T-4 bearings. The other bearings quickly followed, including the T-1 bearing, until the overspeed bolt again tripped the turbine. Once again, a root cause analysis was initiated. The premise was that unit load changes, with their associated thermal influences, might be creating a rotating-to-stationary-component rub. In particular, since the LP turbines had recently been overhauled, we suspected that the tight seal clearances were the most likely source of the rub. Therefore, we began to evaluate the vibration data for evidence of a rub. Since the DM2000 captured vibration amplitude, phase angle, and frequency data before and after the unit trip, we had access to information which could help identify a thermal rub. Characteristically, during a thermal rub, the phase angle and the vibration amplitude both change gradually over time, and the vibration frequency is predominately 1X (synchronous). A quick review of the polar plots from the Data Manager 2000 System (Figure 2) showed that the vibra-

tion amplitude and phase lag increased as the rub-induced bow changed the balance condition of the LP rotor. Therefore, we concluded that an LP turbine rub had occurred.

After diagnosing the LP turbine rub, we began to look for possible thermal influences that may have initiated the rub. For an LP turbine rub, the turbine gland seal system is often found to be the culprit. Upon inspection, it was found that the steam seal system's attemperation (desuperheater) valve was malfunctioning, due to a problem with an air solenoid valve that supplies its controlling signal. The valve problem, in conjunction with the tight LP seal clearances, resulted in a gland seal rub with the LP rotor. After the valve was repaired and temperature control was returned to normal, no further vibration excursions have occurred.

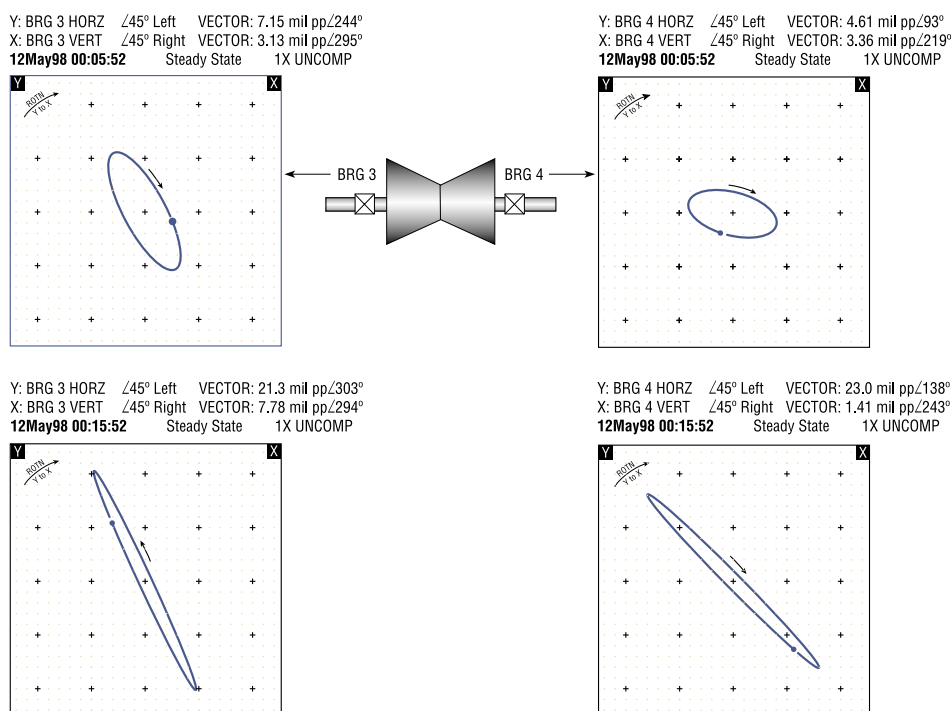
In addition, the timebase and orbit plots for bearings 3 and 4 (Figure 3) clearly showed the restraint and noncircular centerline motion of the shaft. This is very consistent with a rub malfunction. The orbit at bearing 3 was also "reverse" precession (against the direction of rotation) orbit. This is caused by tangential forces acting on the rotor, due to friction from the rub event.

Figure 3a. 1X shaft orbits at bearings 3 and 4. Top plots show response shortly after startup. Bottom plots show effects of thermally-induced rub.

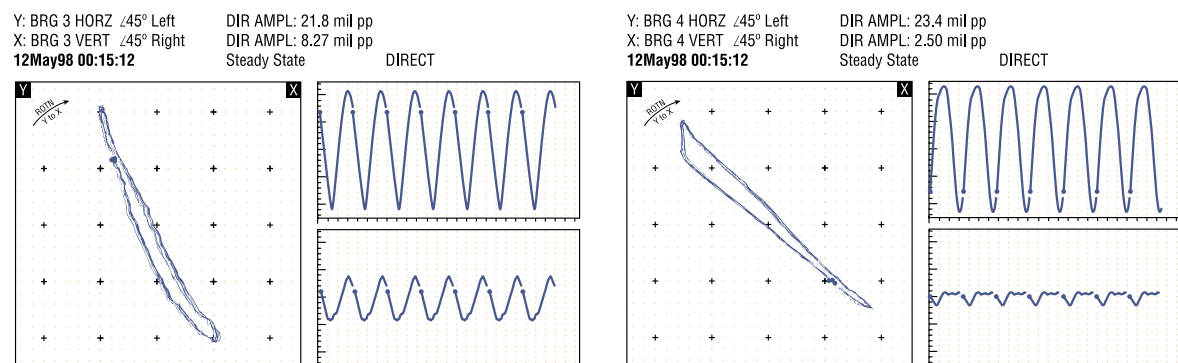
Figure 3b. Direct orbit and timebase plots of response due to thermally-induced rub at bearings 3 and 4. Notice truncated response of waveform in positive X probe direction at bearing 4 indicating duration of contact. Corresponding flat area of orbit shows orientation of rub location.
